**The City of Bellevue
Development Services Department
Land Use Staff Report**

Proposal Name:	Meydenbauer Vegetation Management
Proposal Address:	707 94th Avenue SE
Proposal Description:	The applicant requests a Critical Area Land Use Permit to approve a Vegetation Management Plan to mitigate for disturbance of a steep slope critical area for new utility access to an existing single-family residence.
File Number:	20-100006-LO
Applicant:	Kenji Hoshide, Hoshide Wanzer Architects
Decisions Included:	Critical Areas Land Use Permit (Process II. LUC 20.30P)
Planner:	Mark C. Brennan , Associate Land Use Planner
State Environmental Policy Act Threshold Determination:	Exempt
Director's Decision:	Approval with Conditions <i>Elizabeth Stead</i> <hr/> Elizabeth Stead, Land Use Director Development Services Department
Application Date:	January 2, 2020
Notice of Application Publication Date:	February 6, 2020
Decision Publication Date:	June 25, 2020
Project/SEPA Appeal Deadline:	July 9, 2020

Meydenbauer Residence
707 94th Ave. SE
Site Assessment and Planting
Mitigation Plan

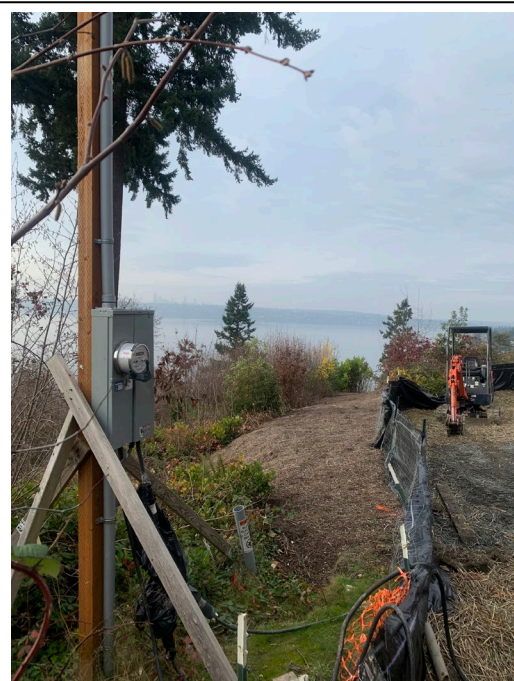
The area of disturbance is a roughly 1500 ft² (10' x 150') corridor that was previously cleared to allow for the trenching and installation of underground utilities. The corridor travels east-west and intersects a steep geologically critical area as defined by the City of Bellevue. At the time of my visit

Image 1. This view to the west shows the extent of the disturbed area, now covered with a thick layer of woodchip mulch.

the trenching and utilities installation had long been completed. What remains is a well mulched non-vegetated corridor.

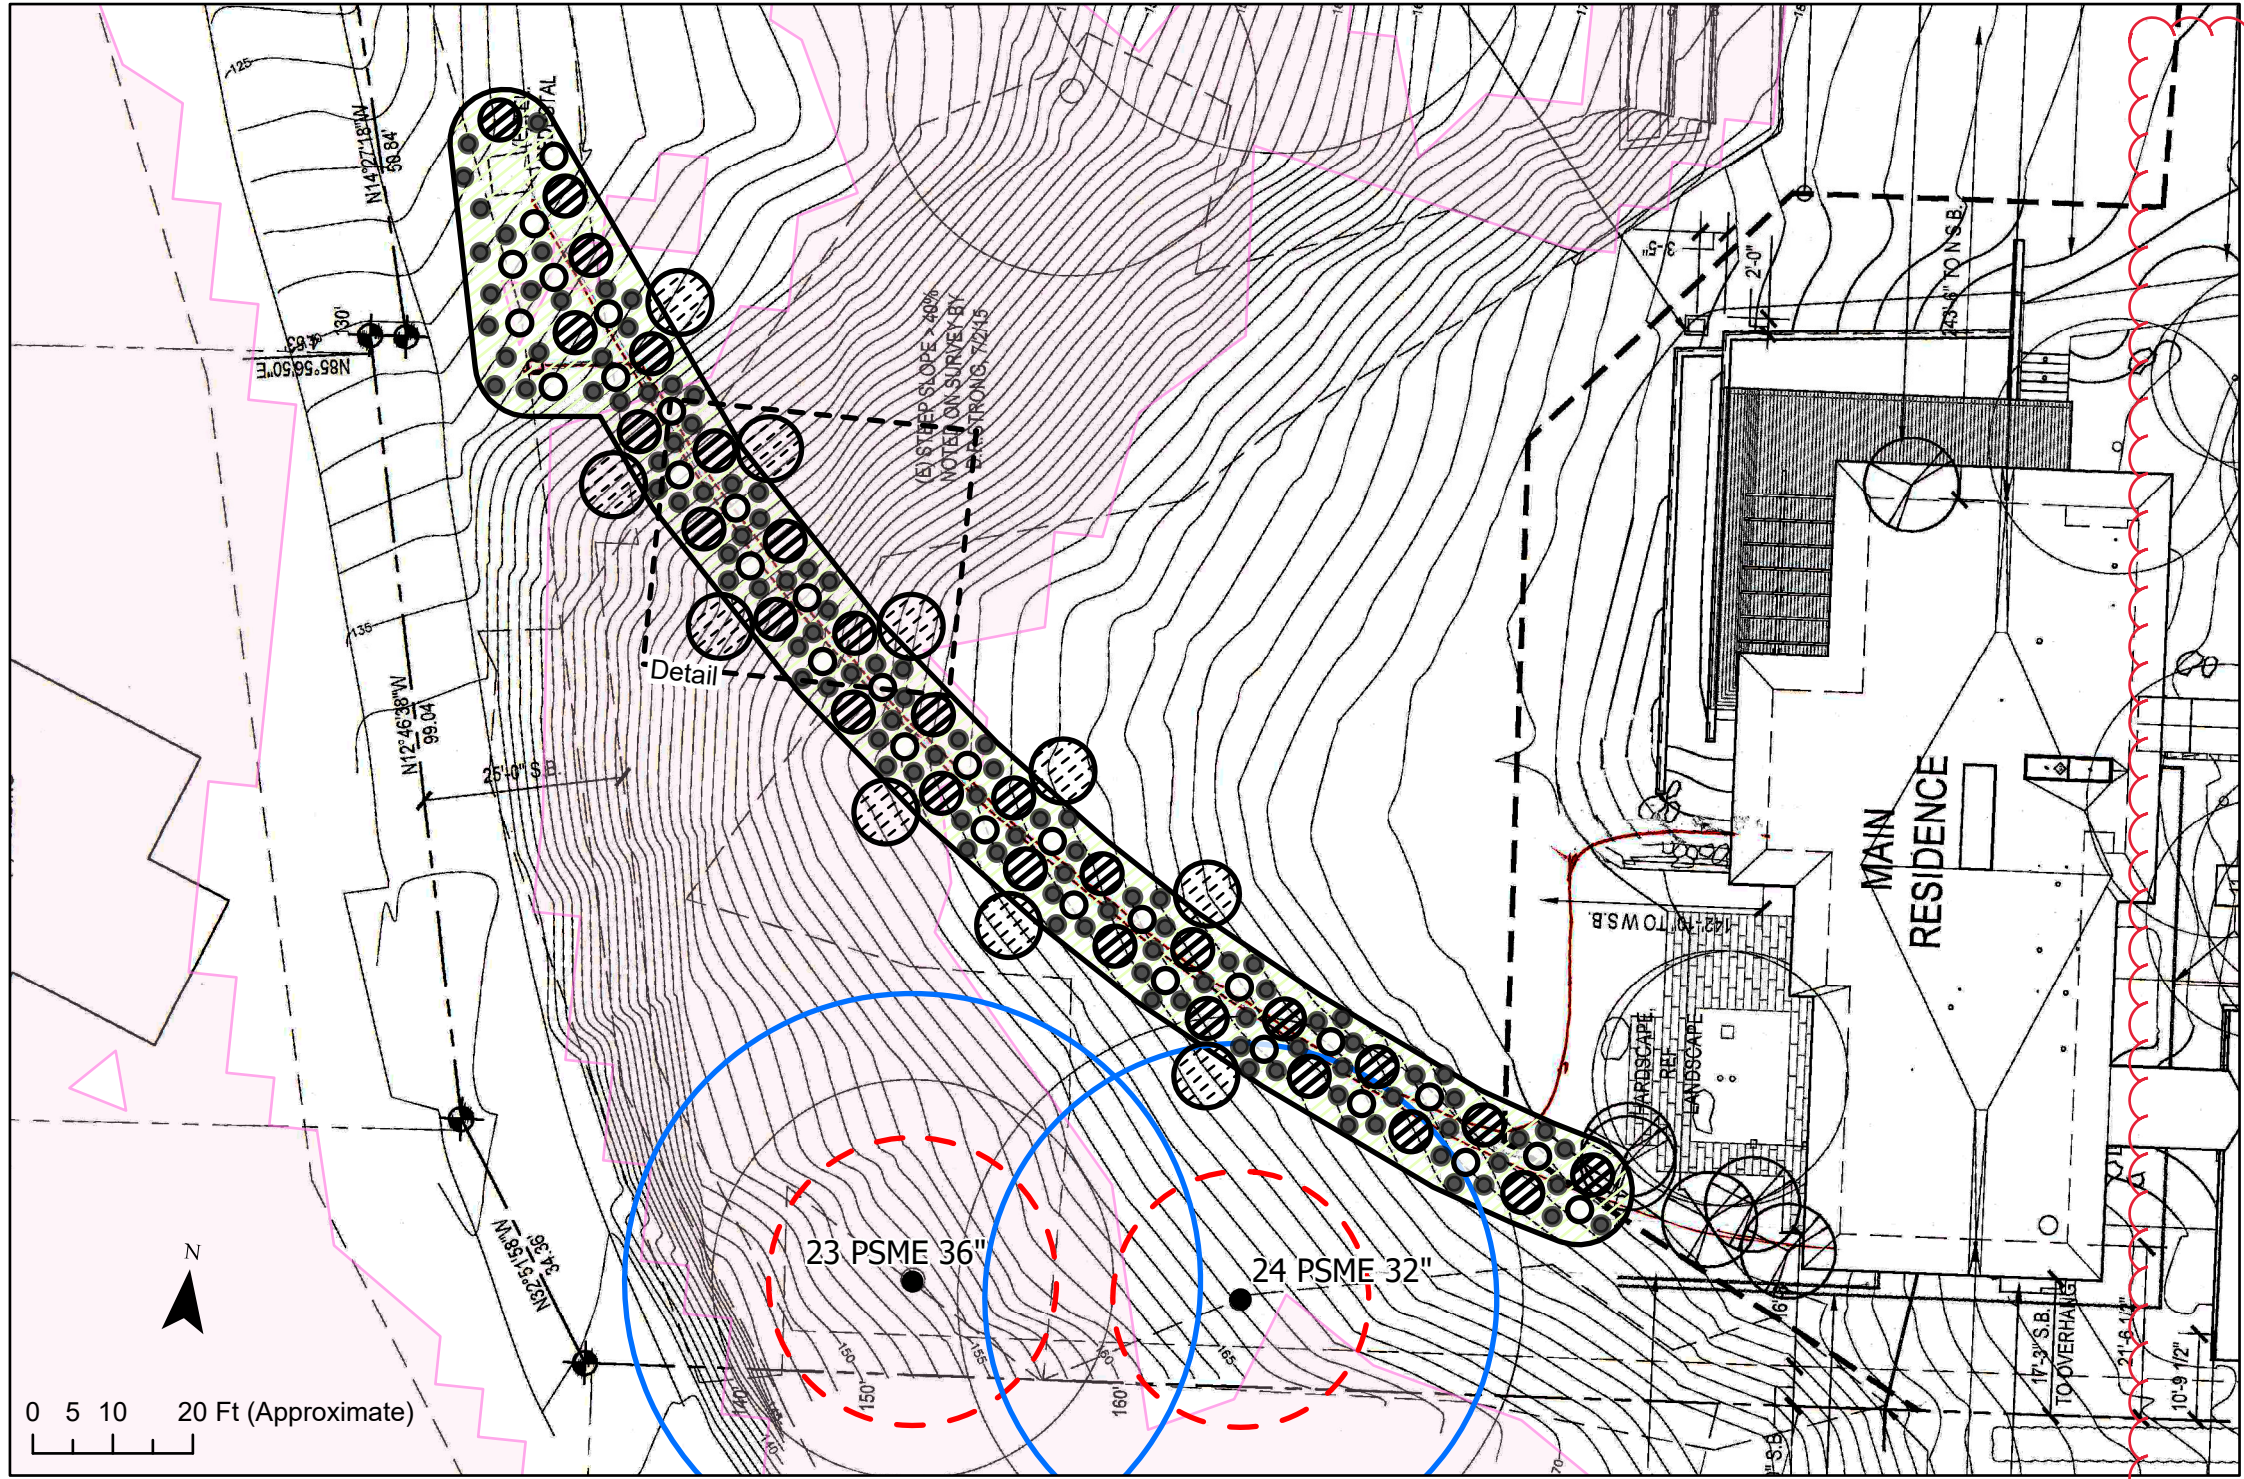
Figure 2: Site Assessment and Planting Mitigation Plan

<div>Urban Forestry Services BARTLETT CONSULTING <small>Divisions of The F.A. Bartlett Tree Expert Company</small></div>	SHEET TITLE			FOR	
	PLANTING PLAN DETAIL			Meydenbauer Residence Bellevue, WA	
	Sheet 1 of 1	NOT TO SCALE	04-24-20	URBAN FORESTRY SERVICES BARTLETT CONSULTING 15119 McLEAN ROAD MOUNT VERNON, WA 98273	HOLLADAY T.P.
SHEET #	SCALE	DATE	PREPARED BY	DRAWN BY
